THE ELECTROCHEMICAL FATIGUE SENSOR: A NOVEL SENSOR FOR ACTIVE FATIGUE CRACK DETECTION AND CHARACTERIZATION

Brent M. Phares, PE, Ph.D.
Material Technologies, Inc.
702 NW Boulder Brook Dr.
Ankeny, IA 50023
USA

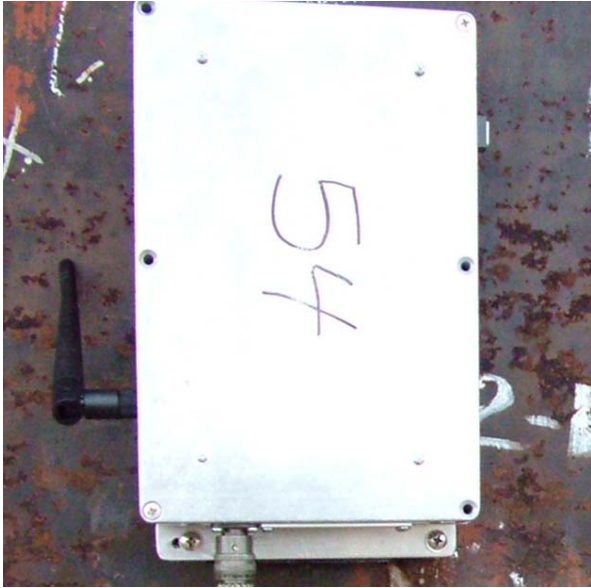
The battery-powered, wireless MATECH potentiostat, shown in Figure 2, provides all of the features necessary to collect data in the field. The potentiostat is compact, lightweight, and provides isolated channels for the R sensor and the CM sensor. The MATECH potentiostat features onboard A/D conversion, data collection to a removable MMC card, wireless data streaming, and an easy to use wireless setup for bias, gain, and sample rate.

Figure 2 The EFS Potentiostat.

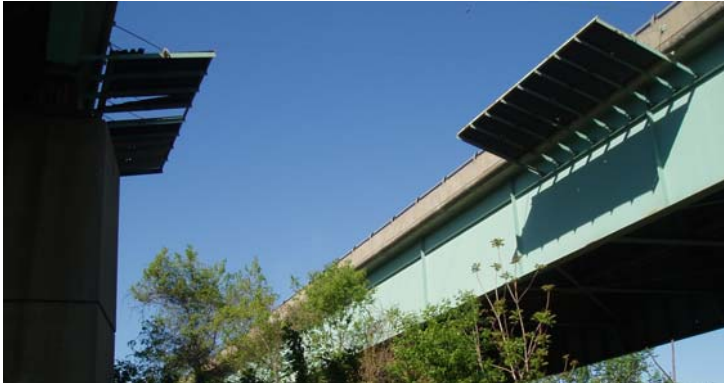
The dual 15-span steel bridges running north-south on I-476 over the Schuylkill River in West Conshohocken, PA was inspected by MATECH preliminarily on May 1, 2006 and with the EFS system on October 5, 2006 and is shown in Figure 3. The structure was constructed in the early 1970's and cracking was reported at the toes of the welds above the bearing locations on the northbound and southbound spans at Pier 11 and within the girder webs at the same locations. The following locations were evaluated with the EFS system:

Figure 3. The I-476 bridge.

The results summarized in Tables 1 through 3 lead to some important findings. First, on the I-476 Bridge, the stop drill holes appear to be of a large enough diameter to have arrested crack growth. However, cracks along the toes of the welds are continuing to grow at a fairly accelerated pace.

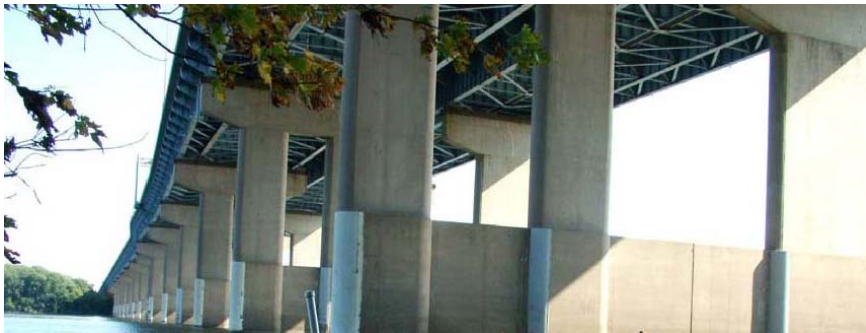
The second tested bridge was the southbound span of a dual 23-span bridge system located on I-81 over the Susquehanna River just north of Harrisburg, shown in Figure 4. A preliminary inspection was performed on May 2nd with the EFS inspection performed on October 10 and 12, 2006. The structure was built in 1972 with the first full year of traffic in 1976. Fatigue cracking was reported during a biennial inspection. The cracking is the result of out-of-plane bending in the girders and high stress range levels. The following locations were tested on the southbound span:

Figure 4. The I-81 bridge.

At the I-81 Harrisburg Bridge, it should be noted that the MATECH team detected a crack not previously reported at Girder 5, Span 10, Floorbeam 1. This location contained a connection detail similar to those which exhibited crack growth elsewhere on the bridge. Results indicate that microplasticity is already occurring in this area and that there is a good chance of crack initiation.

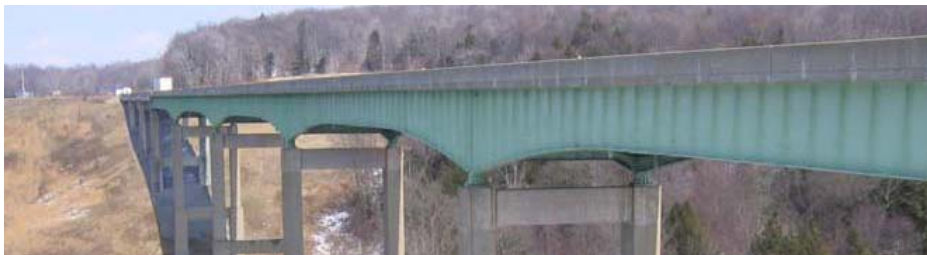
The third bridge inspected is the I-80 eastbound 6-span bridge located west of Clarion, PA in Clarion County over the Canoe Creek shown in Figure 5. A preliminary

Figure 5. Bridge I-80

The I-80 Canoe Creek bridge cracks have, in general, been stabilized. The numerous drill stops and retrofits seem to have slowed the crack growth. Additionally, it is possible that the cracks had gotten so long that the stress field around the area of the crack tip is now below critical levels. It should be noted that testing at one location, the connection of Girder 2 to Floorbeam 26, revealed that there is microplasticity in the area of the crack and that future crack growth is likely in this area.
